# Nav-Watch Report 2020

## A Condition Survey of the Grand Canal, Royal Canal & River Barrow Navigations

Expert observations and 248 reports of navigational difficulties encountered on the Canals & Barrow navigations

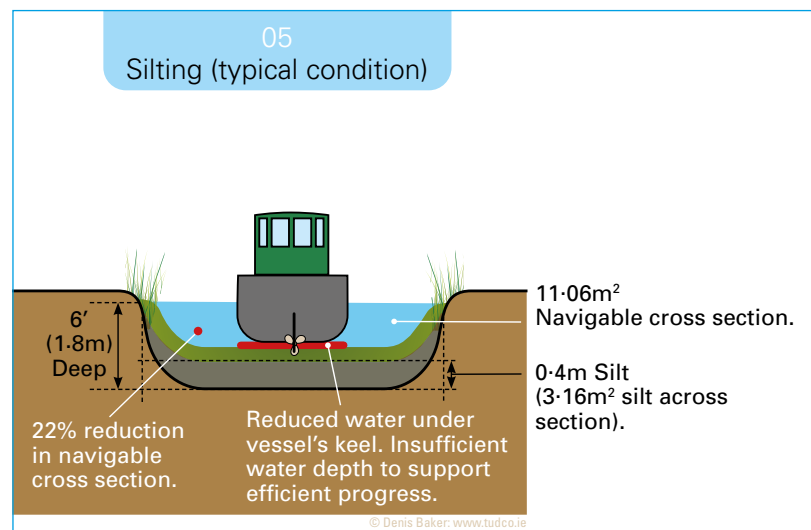
Figure 5 - Excessive silting reduces the depth of water, inhibiting water flow around the vessel.

In situations where the depth of the navigable channel becomes too shallow while a vessel is under way it will experience the 'squat' effect. In this situation, the stern of the vessel will sink lower in the water thus increasing the likelihood of striking the bottom of the channel and increasing the risk of damage. Figure 5 above shows how silting can reduce the navigational cross section by 22%. This was determined with

the use of a measuring stick, gauging the depth of the water to the top of the silt, the stick was then pushed deeper with moderate pressure into the silt until the canal bed could be found by increased resistance by a change in density of the canal bed. At this point a second measurement was taken, the difference in these measurements determined the depth of silting. The average depth was approximately 0.4m.

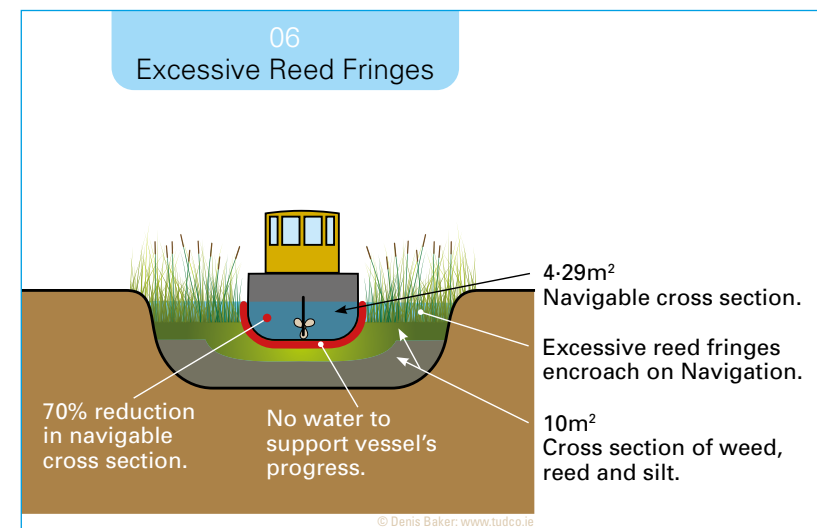
Figure 6 - Canal cross section with excessively large reed fringes

The image above (Figure 6) provides a cross section of the canal as shown in the photograph Figure 14. In this situation, there is an estimated 70% reduction of the navigation channel from the optimal condition. This significantly inhibits efficient progress of the vessel, and according to the vessel progress data in Figure 16 it is impossible to maintain consistent progress of even 1mph. For the purposes of navigating, these areas are only passable when the canal water level is at optimum, it would be virtually unnavigable if the water level was down by more than a few inches.

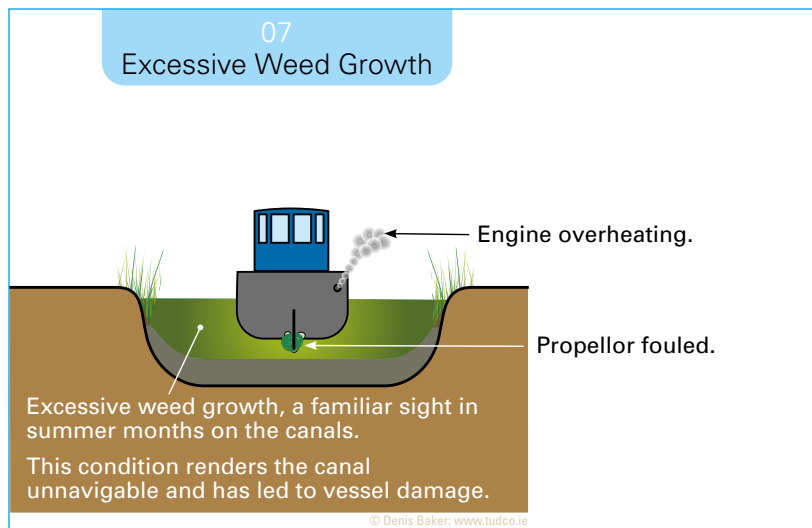
Figure 7 - Excessive growth of obstructive weed filling the whole canal channel

Figure 7 above show how weed takes over the whole navigational cross section, situations of high weed density, as shown in Figure 8, are commonplace and can have damaging effects on boats attempting to navigate the canal and Barrow network during summer months. In Figure 8 (right), the top left picture shows a section on canal with >70% weed density. The bottom left picture shows how the weed has wrapped tightly around the propeller and shaft – this quantity of weed causes significant strain to the

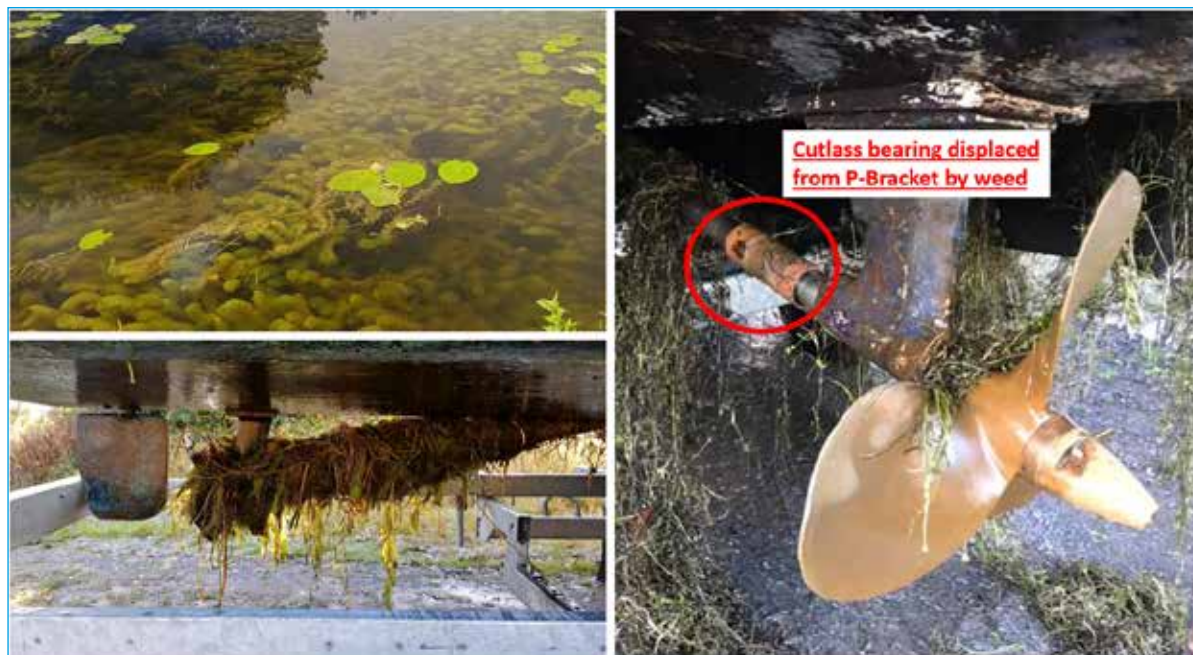
engine and propulsion system of the boat, it is not uncommon for a vessel to suffer damage as a result of navigating through weed this dense.

Frequently the engines of vessels navigating such conditions overheat due to either the excessive load on the propeller or the engine cooling system becoming blocked with weed. The right hand picture of Figure 8 indicates damage caused by excessive weed. The cutlass bearing (a part of the structural alignment of the propeller shaft) was dislodged from the Propeller Shaft Bracket commonly known as a 'P-bracket'. The P-bracket is a strut used to stabilise an unsupported area of the propeller shaft. Normally found just behind the propeller, the shaft spins inside it through a rubber bearing known as a cutlass bearing. Repairing such damage cannot be completed with the vessel in the water, the boat must be removed from the water with a crane/trailer or towed to a dry dock where necessary repairs can be undertaken.

Figure 8 - Excessive weed can have a destructive effect on the engine or stern gear of vessels

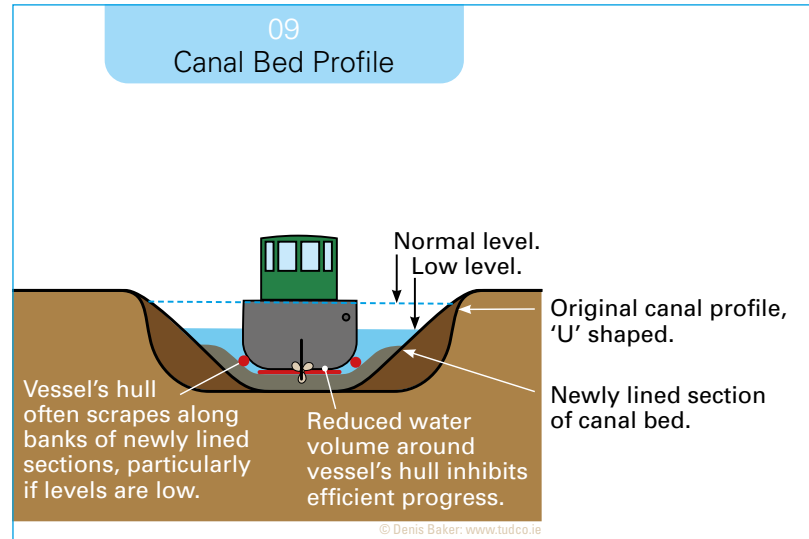
Figure 9 - Relining with sloped banks reduces the navigation channel.

Continued maintenance and improvements to the canals are recognised and appreciated by all boaters. However, there needs to be an understanding of the effects of changing the canal bed profile from U shaped to V shaped. This change has the greatest impact on the Irish Heritage trading boats built for the canals, particularly straight side barges like the M types. They are approximately 60' long by 12' wide require a depth of 3'.5" - 4' (1-1.2m) across their full width of 12'. The sloped banks present challenges to these, and other barges in the following ways:

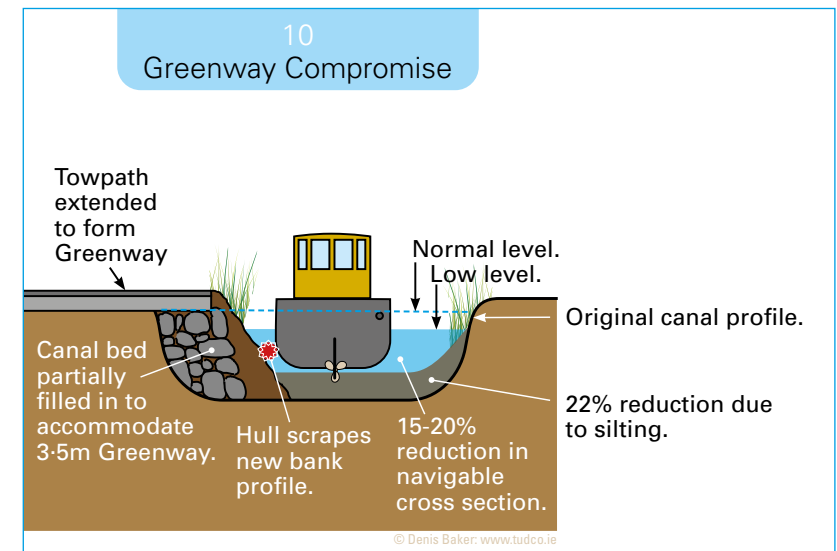
The challenges of navigating a vessel on a reduced level has been outlined previously, this is further compounded with the loss of 15-20% of cross section of the canal navigation due to infilling of the canal for the Greenway, in these two places wide beam vessels have grounded along the infilled sections.

Figure 10 - Widening of green way path width by filling in the canal bed.

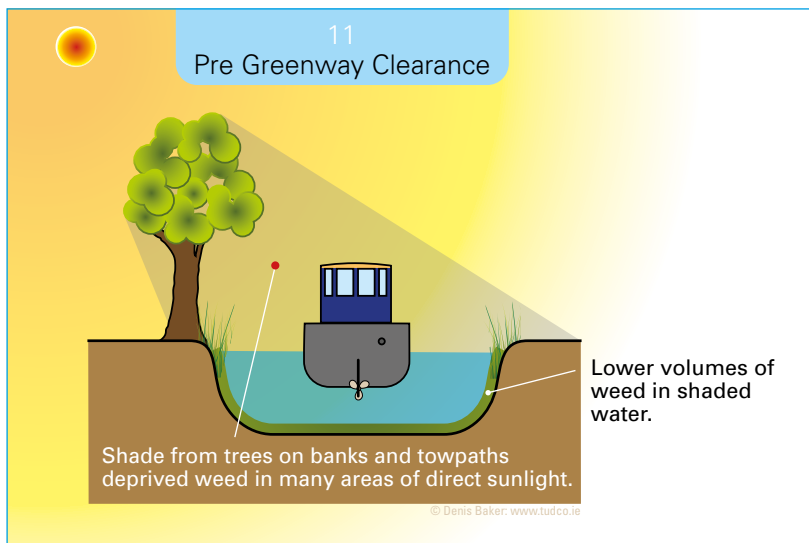
*Figure 11 - An example of pre-Greenway development, adjacent trees providing natural shade to control canal weed growth.*

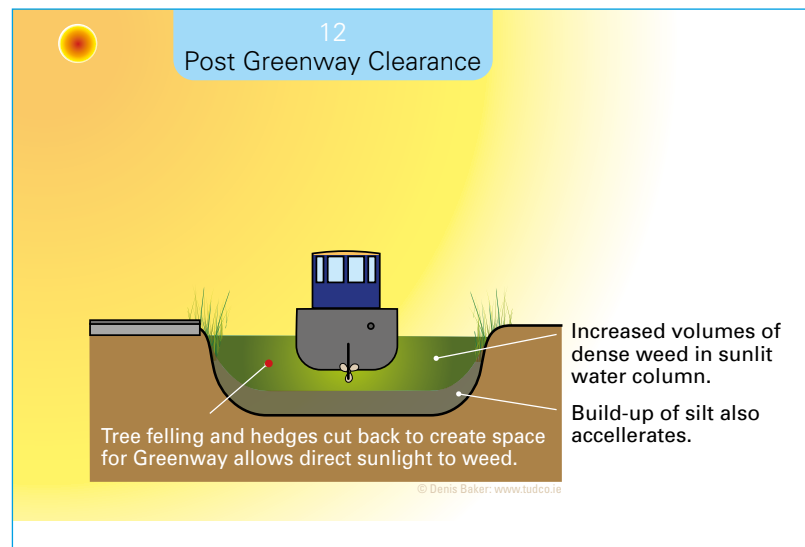
*Figure 12 - An example of post-Greenway development, the canal navigation is fully exposed to the sun, weed grows rapidly.*

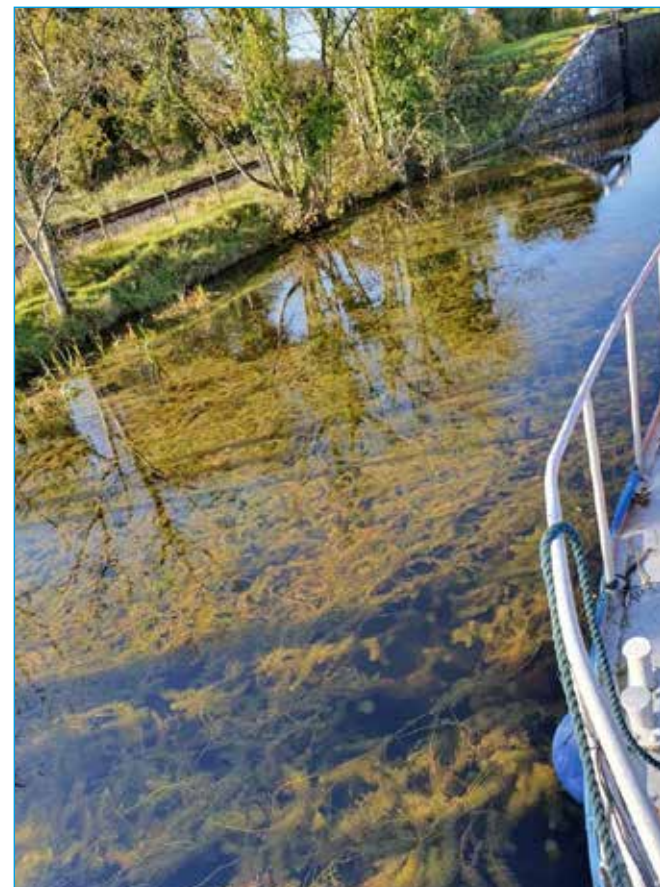
Figure 14 - Common example of obstructive growth of *Myriophyllum verticillatum* October 2019.

throughout the Grand and Royal canals and canal sections of the river Barrow. This density of weed is highly obstructive to vessel progress, the speed drops to hours per kilometre instead of kilometres per hour. The weed density can put severe strain on the vessels engine causing overheating and most likely damage to the gearbox and propeller shaft as shown in Figure 8.

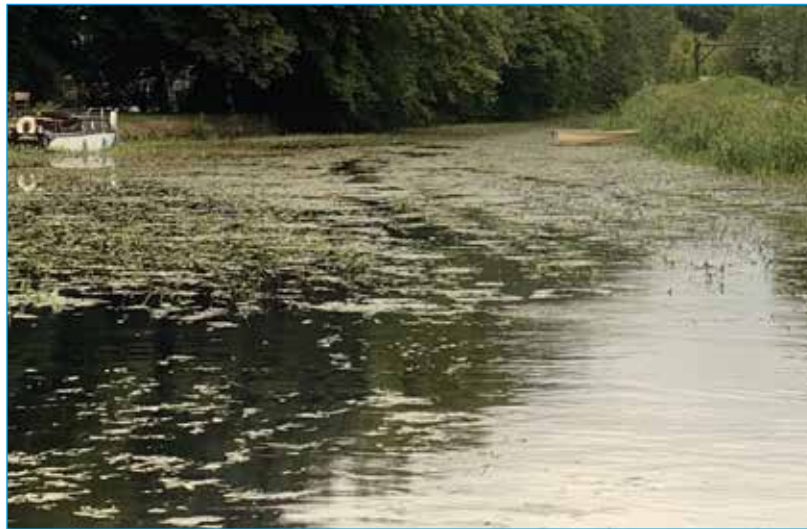
The picture below shows the canal navigation at Levitstown lock on the Barrow navigation (taken in July 2020) - this is practically unnavigable for boating and blueway users. This level of excessive weed is highly obstructive for the boat and completely inhibits efficient progress through the navigation.

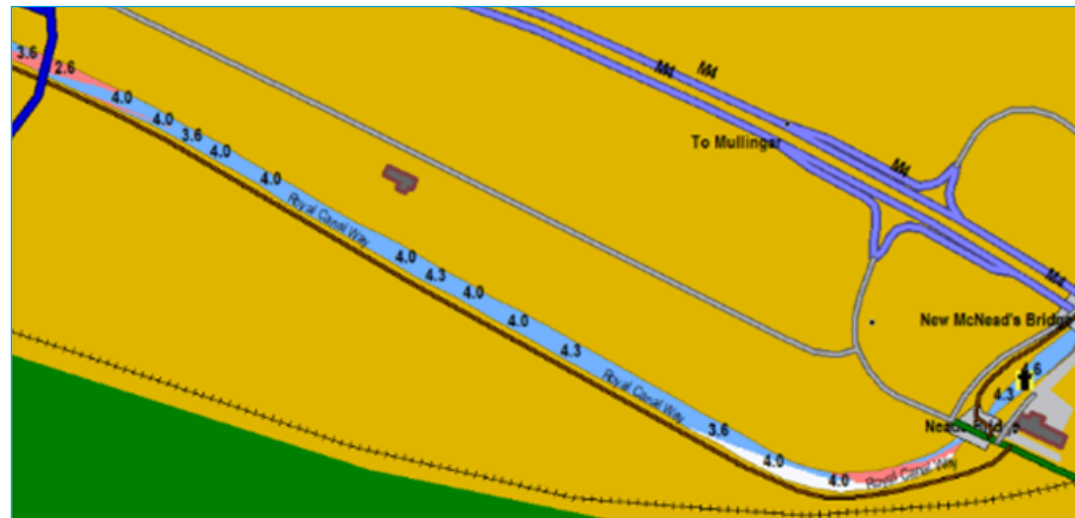
*Figure 18 - Depth Survey of canal centre, the numbers indicate the depth (in ft) from the water surface to the top of the silt layer +/- 3 inches*

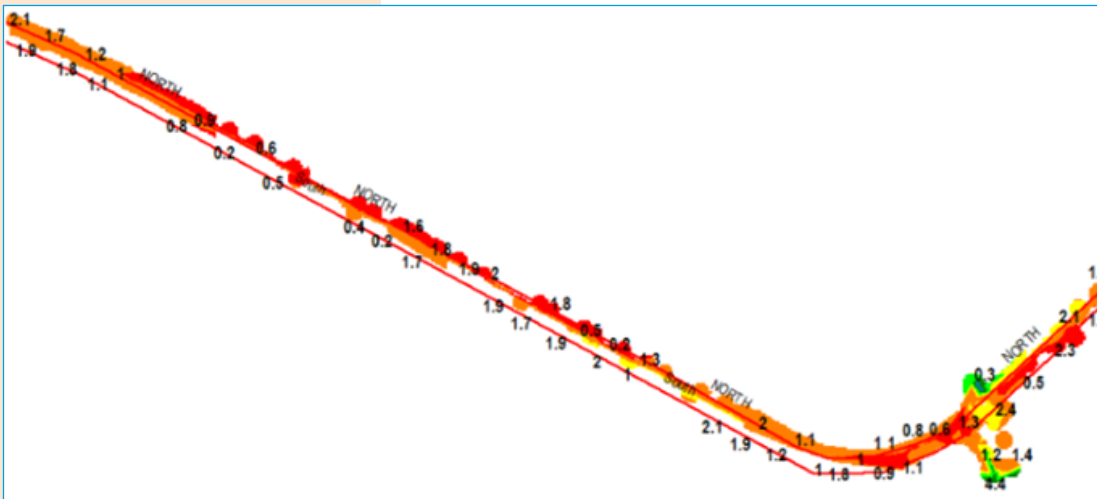
Figure 19 - Vessel progress, the numbers represent the vessel speed (mph) colour contouring is used to highlight areas where the efficient progress of the vessel was inhibited.
