# Nav-Watch Report 2020

## A Condition Survey of the Grand Canal, Royal Canal & River Barrow Navigations

Expert observations and 248 reports of navigational difficulties encountered on the Canals & Barrow navigations

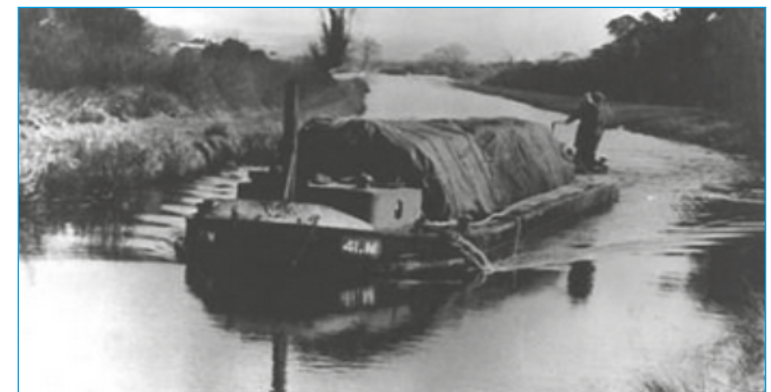
Figure 3 - 41M fully laden trading barge, circa 1950's. (Courtesy of Heritage Boat Association)

Original construction drawings show a canal depth of 5'9". 41M is sitting deep in the water, her deck barely a foot above the surface. This would mean she is drawing up to five feet (her hull bottom is five feet deep in the water). She is still making good headway, which can be determined by the wake she is creating. Many of these M boats are now in private ownership and have been lovingly converted by their owners for recreational use. Without a heavy cargo they sit much higher in the water. They generally draw between three and four feet yet they often struggle to make sufficient progress along the navigation. They are hampered by the build-up of undredged silt on which they run aground.

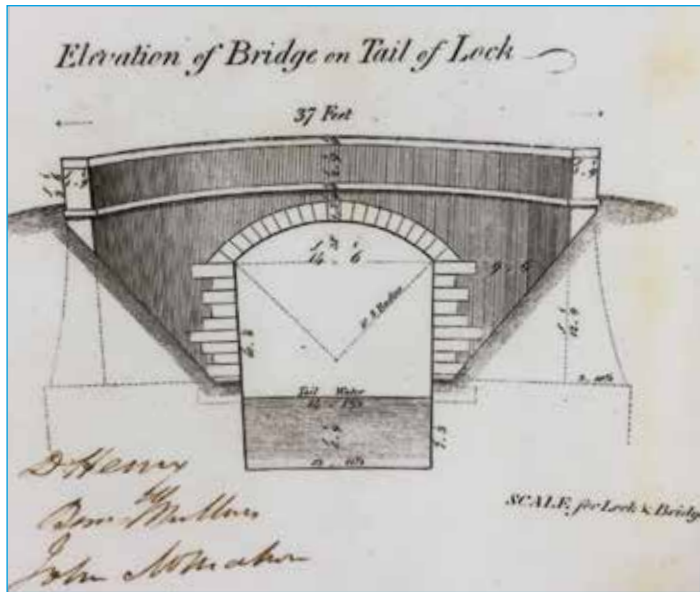
Figure 3A - Original construction drawing of Royal Canal Lock Bridge

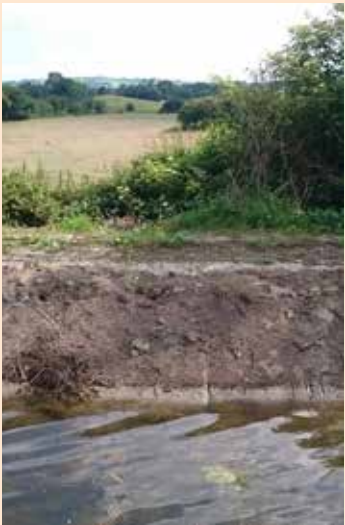
Figure 9 - Relining with sloped banks reduces the navigation channel.

Continued maintenance and improvements to the canals are recognised and appreciated by all boaters. However, there needs to be an understanding of the effects of changing the canal bed profile from U shaped to V shaped. This change has the greatest impact on the Irish Heritage trading boats built for the canals, particularly straight side barges like the M types. They are approximately 60' long by 12' wide require a depth of 3'.5" - 4' (1-1.2m) across their full width of 12'. The sloped banks present challenges to these, and other barges in the following ways:

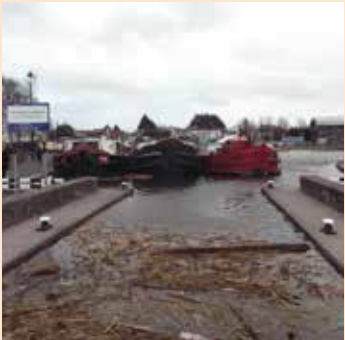
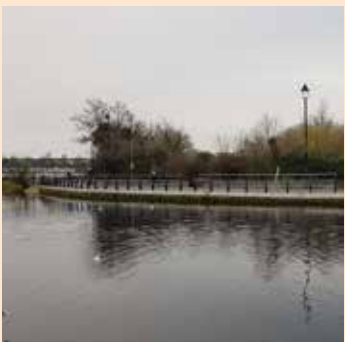
The project team have been made aware of two places where the towpath was widened to facilitate the development of the Greenway, shown in Figure 10. On the Royal Canal between Bond and Jackson's bridges the canal was filled in to accommodate the specification of a wider pathway. The other location, just west of Allen bridge at Kilcock a similar measure was undertaken.

At the time of compiling this report, both of these levels are being maintained at a less than ideal level. The Maynooth level is being maintained at approximately 12" (0.3m) **below the optimum** level due to the risk of overflowing into the town of Maynooth, were there to be significant rainfall in the area. The 16<sup>th</sup> level above Kilcock is being maintained below a level where it leaks through the bank.

The challenges of navigating a vessel on a reduced level has been outlined previously, this is further compounded with the loss of 15-20% of cross section of the canal navigation due to infilling of the canal for the Greenway, in these two places wide beam vessels have grounded along the infilled sections.

Figure 10 - Widening of green way path width by filling in the canal bed.

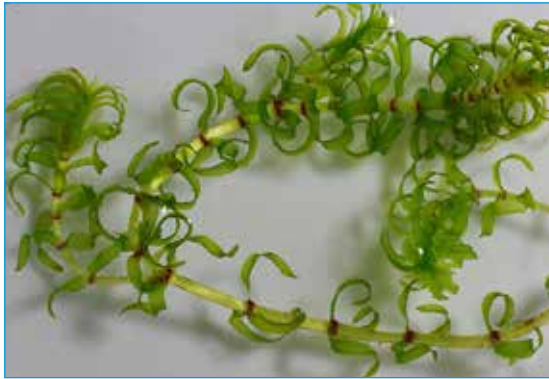
The second most obstructive weed encountered by the authors was Nuttall's Waterweed. It is a perennial aquatic weed which grows rapidly towards the surface without branching out, it over winters (lays down on the canal bed) in Ireland as horizontal shoots which generate new lateral upright shoots as the temperature reaches 6-8°C (InvasiveSpeciesIreland.com 2020).

Figure 15 - Nuttall's Waterweed

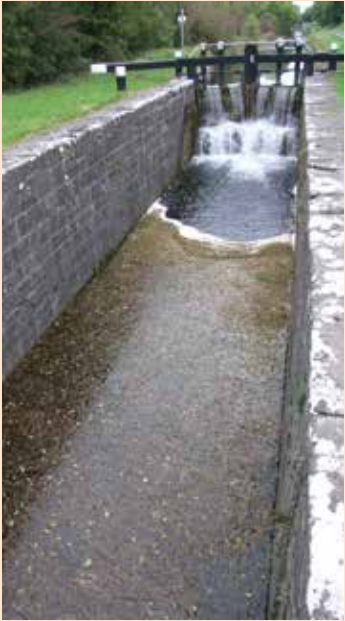
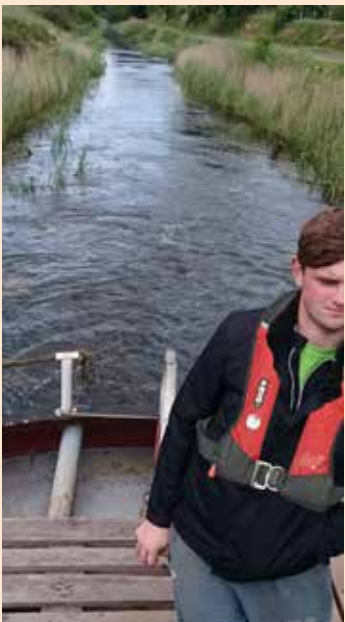
The picture below shows the canal navigation at Levitstown lock on the Barrow navigation (taken in July 2020) - this is practically unnavigable for boating and blueway users. This level of excessive weed is highly obstructive for the boat and completely inhibits efficient progress through the navigation.

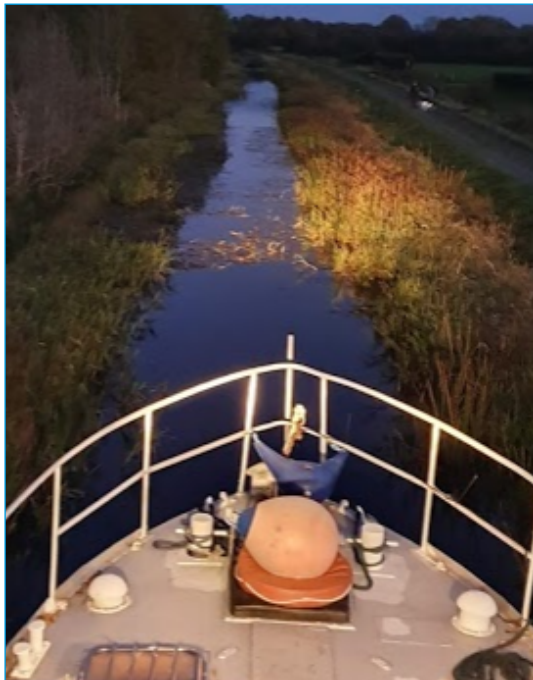
*Figure 17 - Reported issue, excessively large reed fringes encroaching on navigation.*

During the 2019 calendar year, **248** reports were logged by boating canal users as they travelled through the systems, encountering various issues, e.g. the picture below in *Figure 17* highlights where reed fringes have become so thick the navigable channel is reduced to less than the width of the vessel.

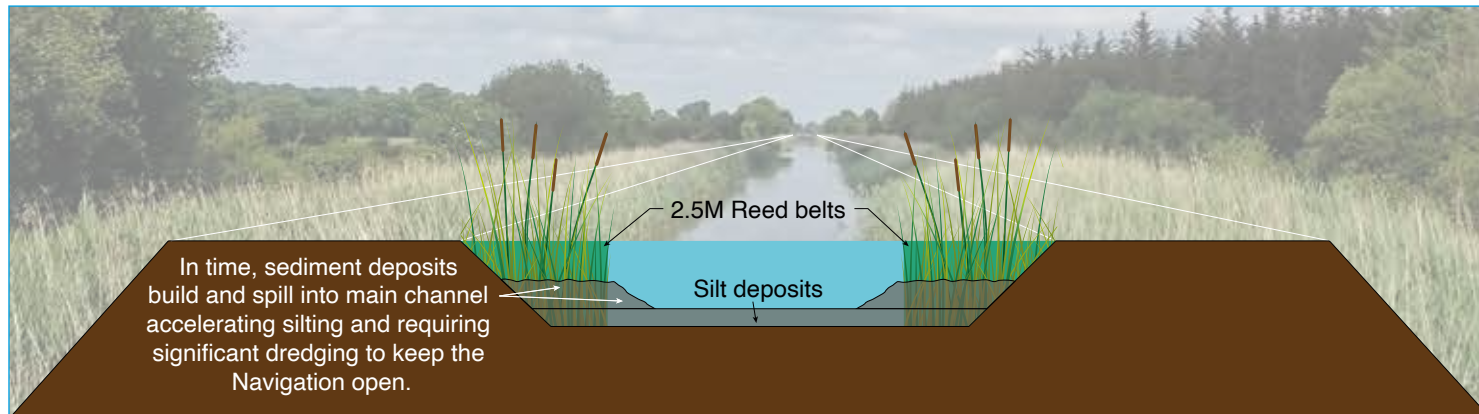
The Reed Fringe continually hampered progress as I travelled both the Royal and Grand, it turned what should be a thoroughly enjoyable experience into a drudged chore. The very long stretches of Reed Fringe slowed progress significantly. Dense Weed in the navigation channel and deepening silt which causes us to bottom out are normally the main hindrances to passage but this added another huge hurdle to the equation.
